ON TECHNICAL ANALYSIS OF CANNON SHOT CRATER ON DELHI IRON PILLAR

R BALASUBRAMANIAM^a, V.N. PRABHAKAR^b AND MANISH SHANKAR^a

A cannon ball that struck the Delhi Iron Pillar surprisingly did not break the Pillar. The history of the ball strike and the probable reason why a second shot was not attempted have been explained. The trajectory of the cannon ball and the surface features of cannon ball indentation area are critically examined. Plaster of Paris depression of cast obtained from the subjected cannon ball crater has been put under digital simulation technique to estimate the diameter of the cannon ball that struck the Pillar. Surprising ability of the Pillar to have withstood the cannon shot and the possible type of cannon used to fire the shot have also been briefly analysed.

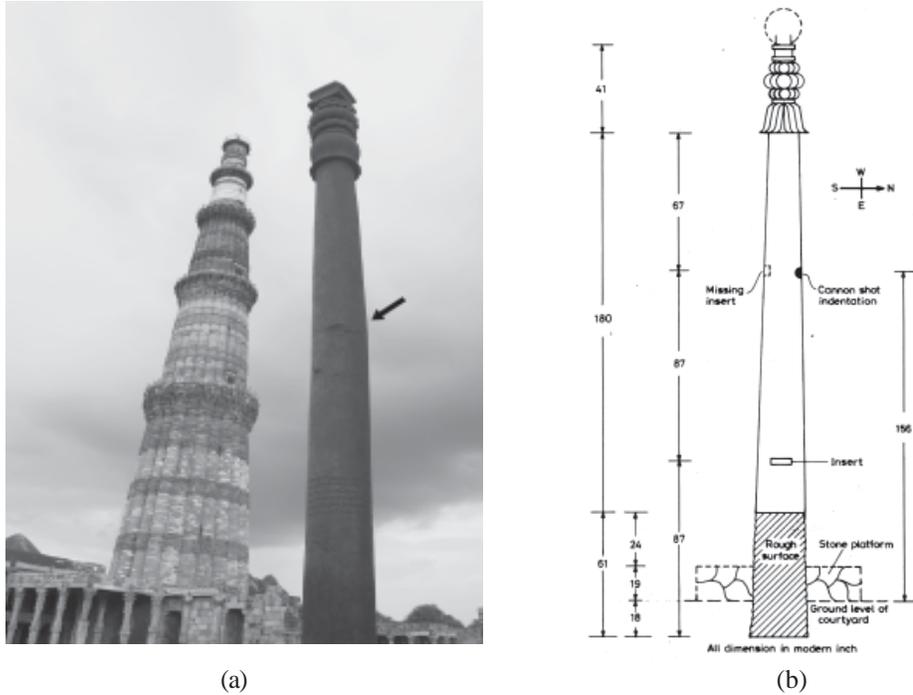
Fig. 1. Delhi Iron Pillar located at the Quwwat-ul-Islam mosque in the Qutub Complex at New Delhi showing (a) the cannon ball strike location on the Iron Pillar (arrowed) and (b) the salient dimensions of the Pillar showing the relative position of the cannon ball indentation and the inserts. The overall symmetric design of the Delhi Iron Pillar is a matter of great appreciation

middle location of the Pillar shown in Fig. 1(a). The indentation is located at a level of about 156 inches from the current courtyard ground level. The salient dimensions of the Pillar are shown in Fig. 1(b), from which the overall symmetric design must be appreciated.

Detailed analysis of the cracks resulting from a cannon shot reveals a single shot would have been sufficient to have broken the Pillar into two, had it been a solid homogeneous structure⁹. The cannon ball was possibly aimed above the central portion of the Pillar (see Fig. 1(b)). The intention being remove the top portion of the Iron Pillar, which contains the artistically meritorious decorative bell capital¹⁶. Nadir Shah was keen to cart away Delhi's historic and famous

They also proposed that a second shot was not attempted, because the deflected cannon ball damaged something else in the mosque. This is an original and interesting proposal that has been elaborated in great detail elsewhere¹⁰. Wayward shooting caused damage to part of the significant Muslim monument, the Quwwat-ul-Islam mosque. Incidentally, it is the first mosque in India proper and the first Indo-Islamic building in India¹⁸. Technical analysis of the cannon ball indentation crater also revealed that the cannon ball which struck the Pillar shattered into smaller pieces after its impact on the surface⁹. It is important to reconstruct the direction of cannon fire and correlate this with the existing structures of Quwwat-ul-Islam mosque. Based on a detailed analysis of the existing structures of the Quwwat-ul-Islam mosque¹⁸ and the position of the cannon shot indentation area on the northern side of the Pillar (see Fig. 1(b), it can be reasonably concluded

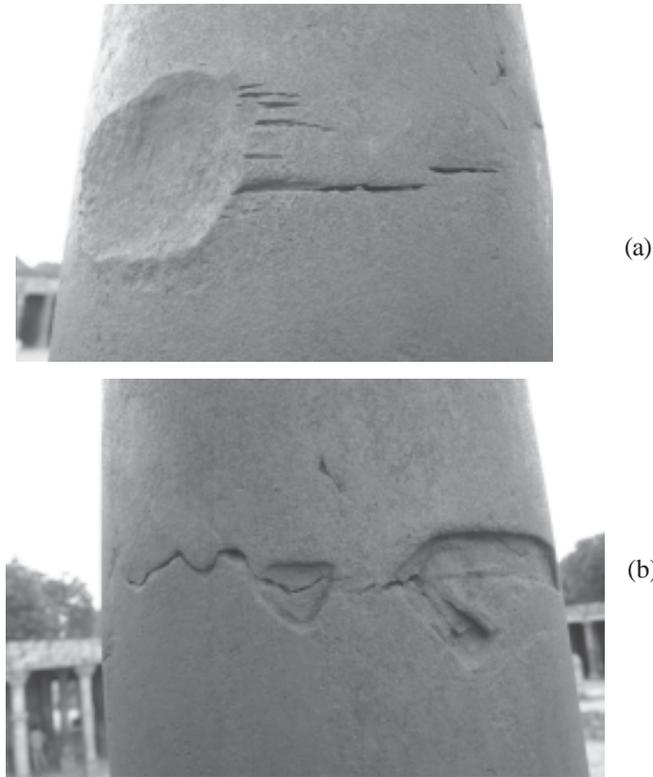
Fig. 2. Close up views (a) crater and (b) cracks in the location diametrically opposite to the cannon ball indentation area

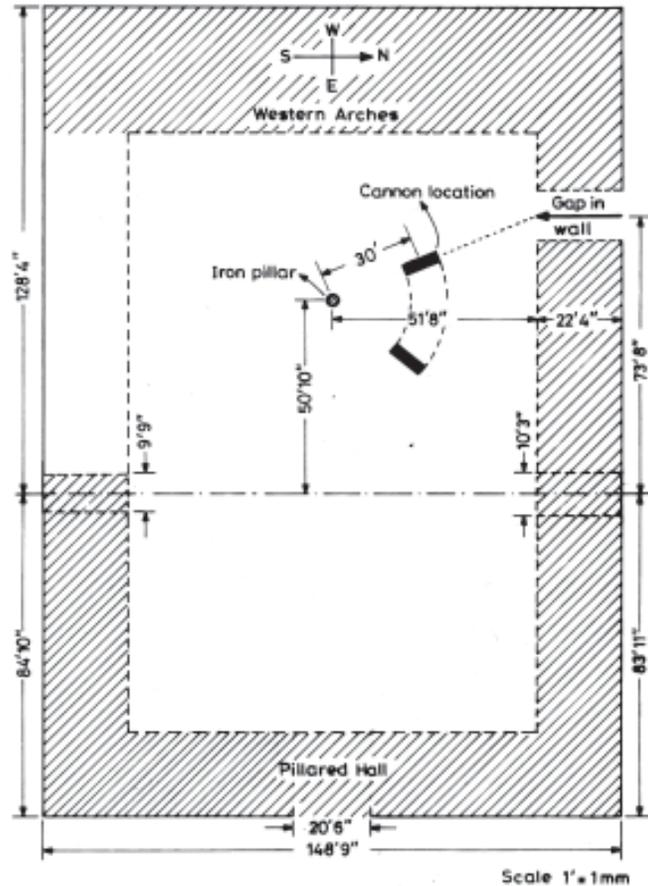
Fig. 3. Schematic of the Quwwat-ul-Islam mosque showing the salient dimensions of the mosque premises and the possible location of the cannon that fired the shot

that the cannon that fired the shot was moved into the courtyard through the gap (which can be still prominently noticed) in the north western portion of the wall of the mosque and positioned on the northern side relative to the Pillar when it was fired. Based on careful analysis of the existing structures in the mosque, it is clear that wayward shot(s) from the cannon fire has resulted in destruction of the structures on the southwestern portion of the mosque. The schematic of Fig. 3 summarizes the scenario, showing the gap in the wall through which the cannon was most likely dragged in, the probable location of the cannon when it was fired and the non-existent structures on the south western portion of the mosque. The existing structures are present only in the shaded hatched area in Fig. 3.

The location of the cannon indicted in Fig. 3 has been determined from the estimated trajectory of the cannon ball. The trajectory has been determined to be 15 degrees based on two approaches, namely analysis of the cannon shot crater and the direction of propagation of the shock wave generated on impact⁹. Utilizing the height of the strike (156 inches) and that the cannon must have positioned at a height of 5 feet (or 60 inches) from the mosque courtyard level (i.e. resting on carriage), it is estimated that the cannon was located at a distance of approximately 30 feet (namely, $358 \text{ inches} = (156-60) / \tan 15^\circ$) from the Pillar when it was fired. This is the basis on which the cannon location has been marked in the schematic of Fig. 3.

fact is that the trajectory points from the bottom to the top thereby confirming that the cannon shot landed on the Pillar on its upward motion from cannon. Another important conclusion is that the angle of the trajectory is 15 degree, as determined using the slanting and the horizontal lines in Fig. 4(b). This angle has been utilized earlier in this communication to estimate the location of cannon which fired the shot on the Pillar (see Fig. 3).

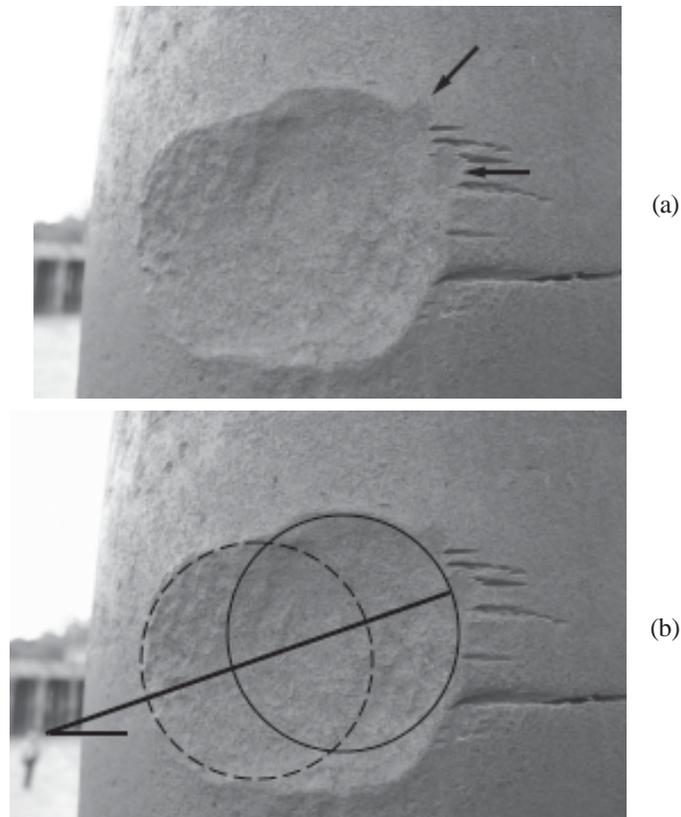
Fig. 4. Close-up view of the cannon ball indentation location: (a) Two shear lips around the cannon ball crater have been arrowed, and (b) analysis of the indentation area showing the location where the cannon ball first made impact (dotted circle) and the location where the cannon ball came to a halt (full circle). The trajectory of the ball is indicated by the slanted line

Evidences, as available from the cannon shot indentation on the surface on the Pillar, need to be first recorded and highlighted. A close-up view of this area is shown in Fig. 4a. The following observations can be readily made. First, the complete impression of the cannon shot is not perfectly circular and the depression is skewed. Prasad and Ray¹³ have earlier also pointed out that cannon ball indentation mark is not symmetrical. The depth at the right side [see Fig 4(a)] of the indentation is more than the left side. The left side of the indentation, due to its lower depth, indicates grazing of the ball on its way to the impact. The exact location of the final impact is on the right side of the indentation.

The direction of cannon shot was from the northern direction, as discussed earlier. Based on the observed surface features, it is possible to further conclude that the cannon ball first made contact on the left side of the indentation area and then came to rest on the right side [shown by full circle in Fig. 4(b)]. The trajectory of the canon ball can also be understood by noting the relative position of the centers of these two circles [see slanting line in Fig. 4(b)]. The important

The depression of the crater proves that plastic strains were generated due to the impact and that there was no cracking at the impact location. This had an important bearing on the consequences of cannon ball impact and this has been explained in great detail elsewhere⁹. The plastic strains generated due to the initial grazing motion of the ball and the final impact can be clearly distinguished on the indentation area [see Fig. 4(a)]. The surface features on the left of the cannon ball indentation area reveal material removal due to the grazing motion of the high velocity projectile. The features on the right reveal higher degree of deformation, caused by the final impact. That the final impact was on the right site of the indentation is further corroborated by a important material evidence, namely the creation of shear lips just at the right of the cannon ball strike location. This is indicated in Fig. 4(a), where two shear lips have been arrowed.

The shear lips [marked in Fig. 4(a)] indicate that the material of the cannon ball splintered after its impact and possibly became molten on hitting the Pillar. The ball may not have been of stone because the impact would not have

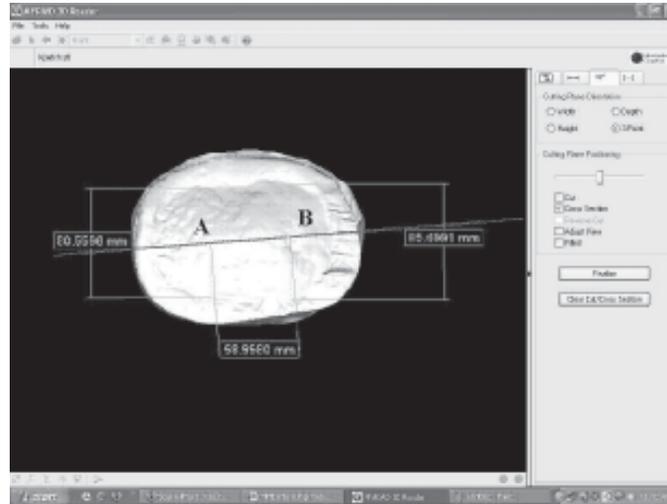
Fig. 5. Three dimensional digitized image of the Plaster of Paris cast after point-mapping of the surface. The trajectory of the cannon ball is given by the slanted line joining A and B

In order to digitally analyze the dimensions of the cast, the cast was first digitized using the Moire fringe imaging method¹⁶. The digitized image of the cast is shown in Fig. 5. The dimensions at different sections could now be obtained from the digitized image. The aim of the study was to obtain the radius of the cannon ball and the procedure for this was as follows. The trajectory of the ball was first marked out from the known trajectory analysis that was performed earlier (see Fig. 5). This was marked on the cross section and it was ensured that the line passed through the mid-points of the two depressions (see Fig. 5). At the slanted line in Fig. 5, the image was cut digitally to obtain the cross section. When

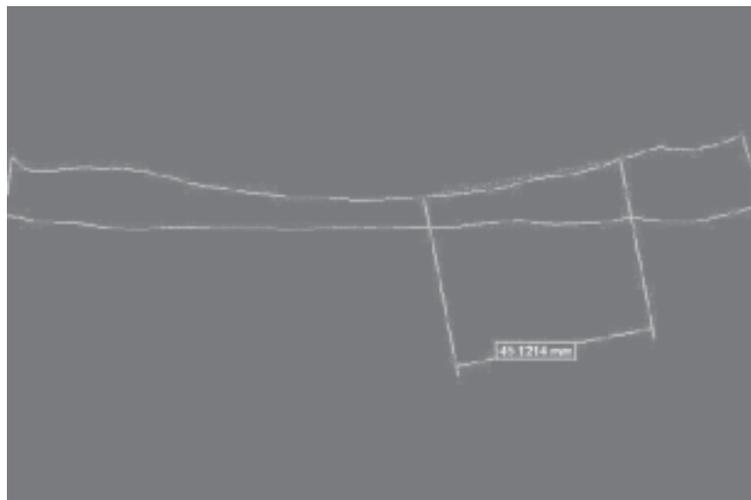
Fig. 6. Cross sectional view of the Plaster of Paris digital image along the slanted line shown in Fig. 5

from the outside the cannon ball mark was not desired and therefore was cut out. The remainder of the arc was also removed and we kept only the region within the arrows, shown in Fig. 6. This image was converted to a binary image for use in MATLAB. The binary image was utilized in MATLAB to approximate fit the best circle for the arc.

The radius of the circle therefore provided the radius of the cannon ball that struck the Pillar. The radius was obtained in pixel units, which was later converted to units of mm. The entire procedure was as follows. The coordinates of the two points A and B on the line (see Fig. 6) were A ($x=832$, $y=207$) and B ($x=568$, $y=258$), which corresponded to length of 268.88 pixels. This corresponded to the real length of 45.12 mm. The correspondence between pixels and real lengths were thus established.

Now, the estimated radius of the circle was 358.54 ($717.08/2$) pixels, which when converted using the established relationship between pixels and millimeters, provides result that the cannon ball that struck the Pillar had a diameter of 120.33 mm. This translates to units of inches as 9.48 inches. This must be considered as an upper bound value because the estimated diameter value includes additional plastic deformation due to cannon impact. Additionally, given the extent of error inherent in this estimation using a plaster of Paris cast, it is reasonable to propose that the diameter of the cannon ball that was fired was approximately nine inches.

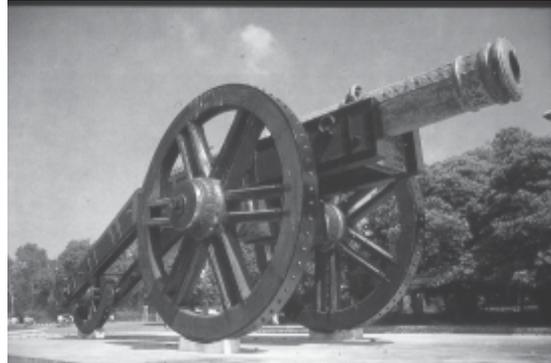
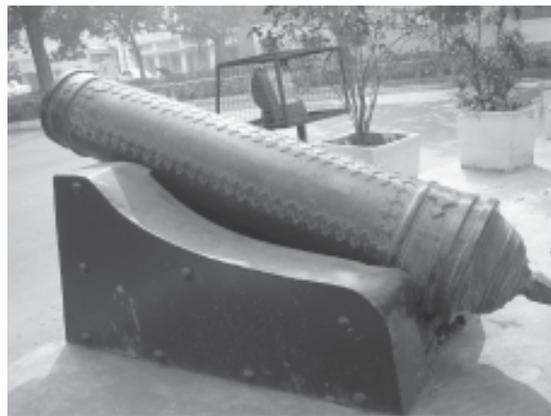
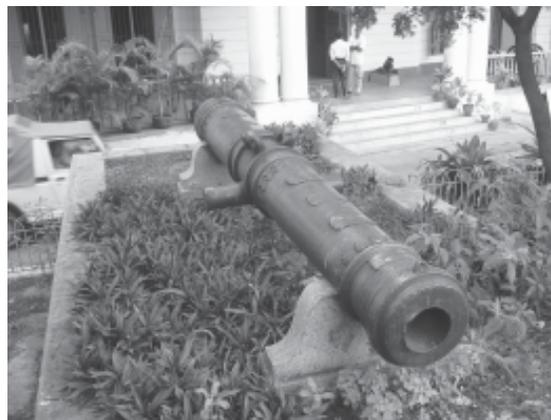
Fig. 7. Example of type of cannon that fire the shot on the Pillar (a) the *Zamzamāh* cannon now at Lahore, (b) Sind cannon located inside Fort William in Kolkatta and (c) Sind cannon located outside the Archaeological Survey of India Museum at Fort St. George in Chennai.

Utilizing this value of cannon ball, it can be further proposed that the bore of the cannon that fired the shot must have been about 9 inches. Therefore if one has to analyze the types of cannon that was used to fire on the Iron Pillar, one has to look at the pieces from the early 18th century that are still present in India and the critical factor to look out for will be that the diameter of the inside of the cannon barrel must be about 9 inches. In this regard, the *Zamzamāh* cannon [see Fig. 7(a)], now at Lahore, and the Sind cannons now located inside Fort William in Kolkatta [see Fig. 7(b)] and outside the Archaeological Survey of India Museum at Fort St. George in Chennai [see Fig. 7(c)] can be considered similar to the cannon that fired the shot on the Iron Pillar due to their time period of construction and also their bore diameter is about nine inches.
